Bulletin BES 13-06

Subject: Safety issues using lightweight rotors

Condition: Catastrophic examples when rotors fail

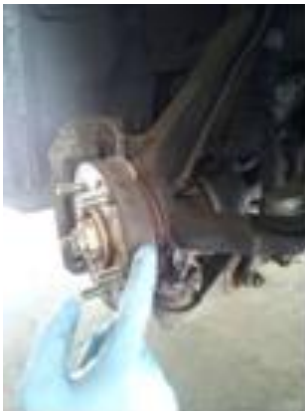
This is the hat section of the rotor still attached to the wheel hub. Notice the actual braking surface or plate is totally missing

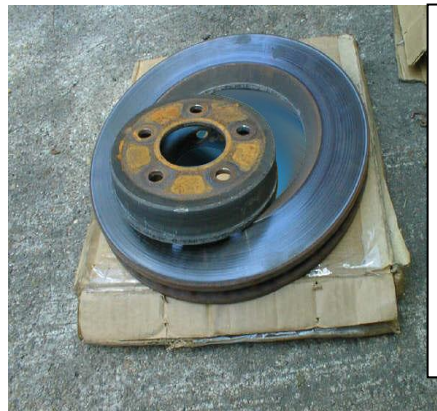
This is the hat and plate completely separated. Poor casting or not following OE design may have caused this.

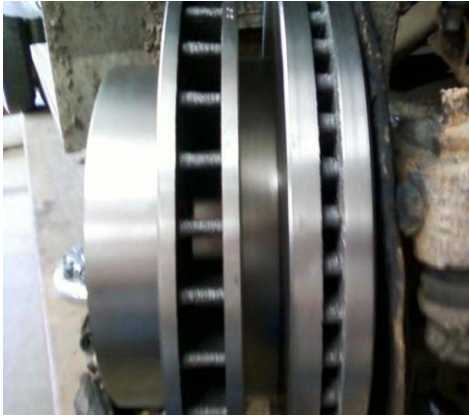
We have actually weighed our rotors and compared it to some of our competitors. In some cases we've seen over 20% weight reduction by eliminating vanes, increasing airgap between plates and not using OE design.

Here is an example of a poorly designed lightweight truck rotor next to ours. Would you install the rotor on the left on your customer's truck?

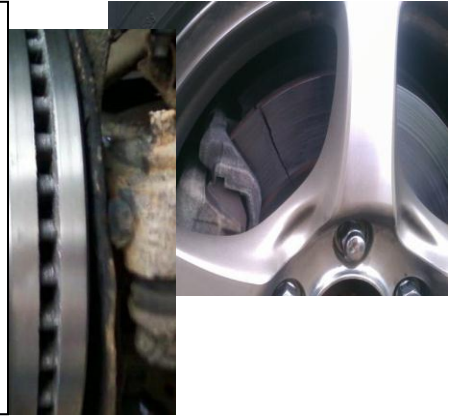
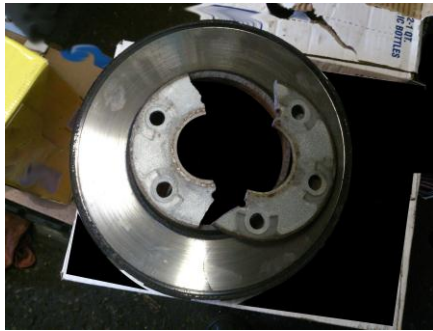
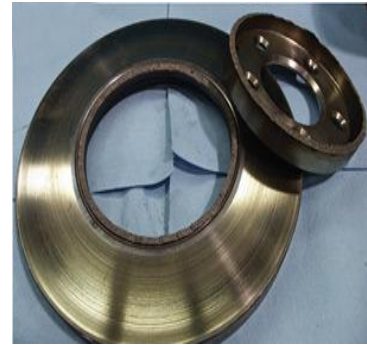
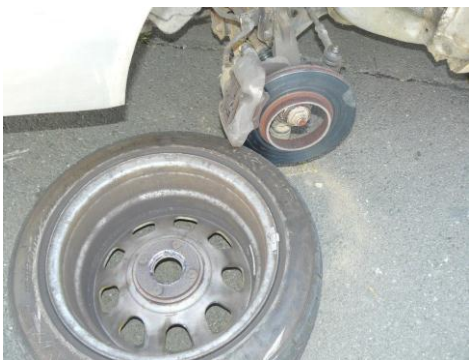
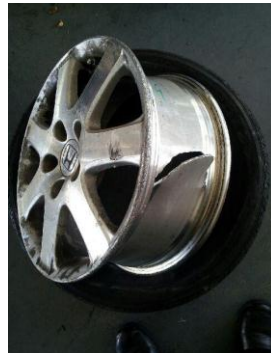
There is usually other damage to the vehicle. In this case the tire and wheel. Body damage occurs when tire contacts fender.
