Bulletin BES 03-20

Subject: Intermittent scraping noise from rear of vehicle. Redesign of Spring Clips on Parking Brake Shoes provides better support, and reduces noise.

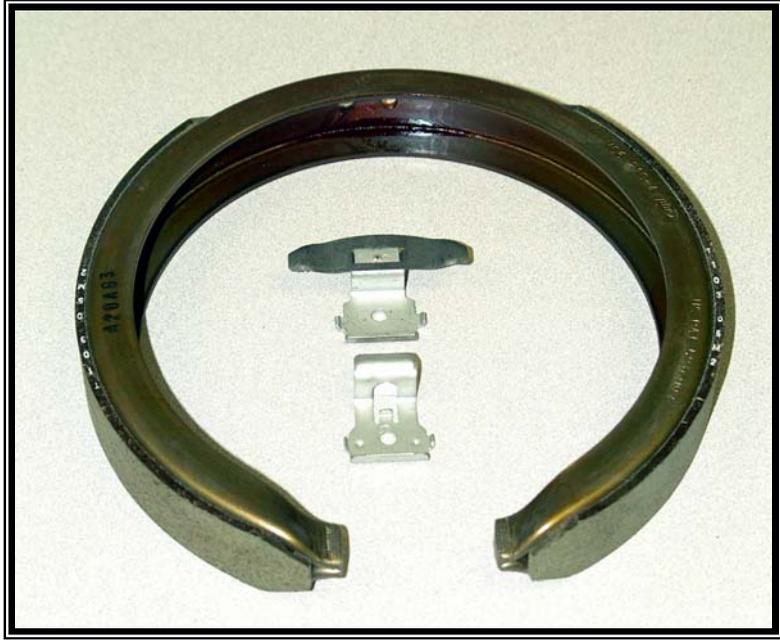
Condition: GM made a running change to the design of the spring clips in the 781 brake shoe sets. We have also made the same change. The new spring clip design has a wider contact area with the parking brake band. (See illustration page 2). This design improvement provides increased support of the brake band, which also reduces noise.

Repair Procedure: Detailed installation instructions are included with the new parking brake shoes. Note: it may be necessary to relieve the tension on the parking brake cables by loosening the nut at the equalizer. When removing the rotor, slowly turn the brake rotor and pull outwards simultaneously, keeping the rotor square to the axle. If the rotor jams during removal, do not force it off. Push the rotor back to its original position and attempt again. Forced removal of the rotor may damage the parking brake hold down spring and shoe. The rotor may not be easily removed because of a rust ridge built up on the outside edge of the drum and hat section of the rotor. After removal of the rotor, clean the rust ridge from the drum section of the rotor by using a grinding stone. The parking brake surface does not have to be resurfaced. Rear brake pulsation cannot be identified with this type of brake system by applying the parking brake while moving. Minimum thickness of the parking brake shoe lining in any given spot is 0.060 inches.
