Bulletin BES 07-24

Subject: New brake rotor and pad design

Vehicle Involved: 1994 – 2000 Kia Sephia and Spectra

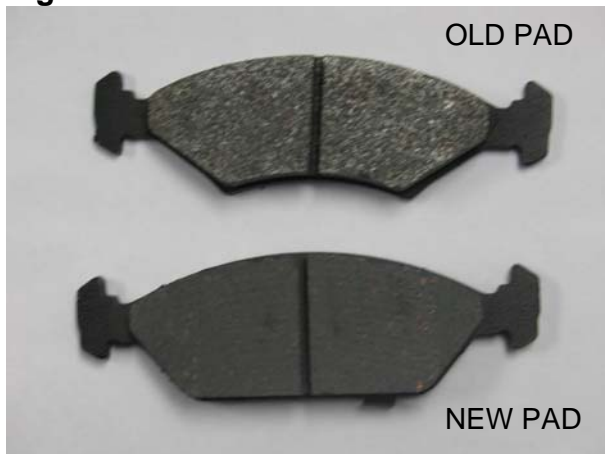
Fig 1

Condition: premature wear on pad and rotor.

Repair Procedure: Due to premature wear the brake rotor vent design has been changed as seen in fig 1. The brake pad surface also has been increased from 37.5 sq. cm to 43.0sq. cm as seen in fig 2
