## Bulletin BES 04-17

**Subject:** Slow speed brake noise (Fix: caliper piston boot lubricant)

**Vehicle Involved:** 1999-2003 Chevrolet Malibu  
2004 Malibu Classic  
1999-2004 Oldsmobile Alero  
1999-2004 Pontiac Grand Am

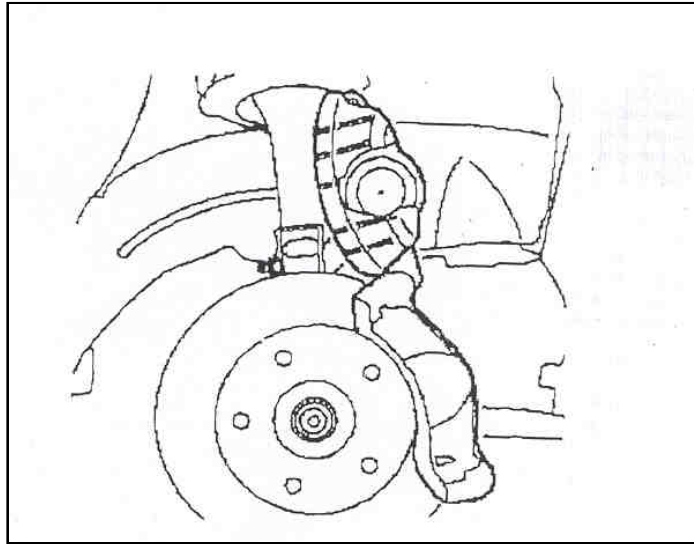
Figure 1.

**Condition:** A slow speed brake noise or creak may be caused by the caliper piston dust boot to caliper piston contact area being dry.

- Do not push the caliper piston in at this time. Remove the lower caliper bolt and swing the caliper upward. (Figure 1)
- Clean the caliper piston boot and boot to piston contact area. Use an approved GM brake cleaner.
