Bulletin BES 01-15

Subject: Leading/Trailing type rear brake shoe systems may be the cause of lack of stopping power, excessive pedal pressure/travel, and increased front pad wear.

Vehicles Involved: 90's GMC and Chevrolet RWAL equipped pick-up trucks.

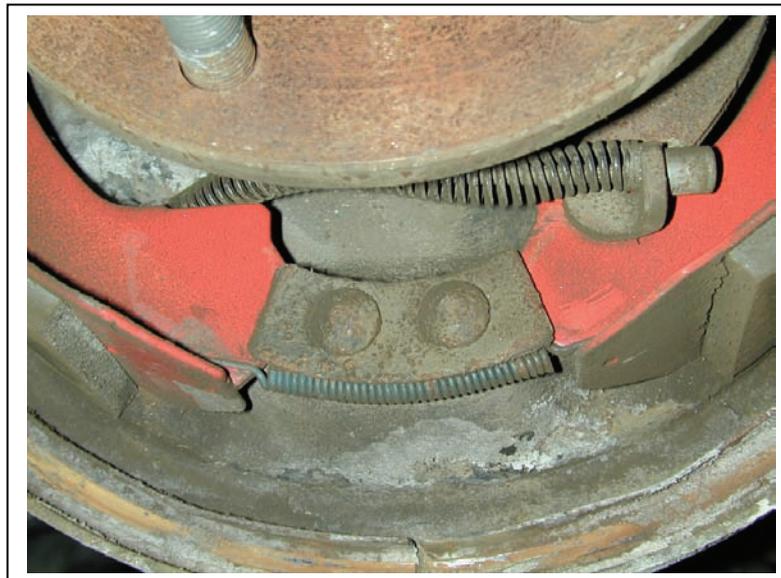
Repair Procedure: Symptoms or complaints including lack of stopping power, increased front pad wear, lower than normal brake pedal, may be the fault of the lower tapered mounting block for the leading and trailing brake shoes. After establishing that the Electro-Hydraulic ABS valve is not leaking internally into the accumulator (Refer to bulletin 98-03), remove the rear drums and perform a visual inspection. First look for any sign of taper wear on the brake shoes. If the top 1/3 of either or both brake shoes is worn a great deal more than the lower 2/3, the brake shoes are not sliding on the lower taper shoe-mounting block. When the brakes are applied, fluid pressure forces the wheel cylinder pistons outward pushing the upper portion of the brake shoes into the drums, leading brake shoes are somewhat self-energizing. They must be able to slide on the tapered lower mounting block. Likewise when backing the vehicle up, the rear shoe (trailing shoe) must slide on the tapered lower mounting block. If the shoes just pivot on the lower mounting block, taper wear on the linings will occur and the vehicle will require excessive pedal pressure to stop. As a result of the increased pedal pressure, excessive pedal travel may be experienced. When inspecting the brakes tap downward on the top of each brake shoe with the palm of your hand. The brake shoe should easily move downward. Then tap upward seating the shoe in its normal at rest position. Again the shoe should move with normal resistance. The shoe to lower mounting block requires lubrication when new shoes are installed or existing shoes serviced. Inspect the block for grooves or rough areas caused by previous lack of shoe to block lubrication.
