Bulletin BES 02-22

Subject: Improper installation may result in interference with the compact spare tire, and reduce brake pad life.

Vehicle Involved: 1997-2001 Chevrolet Malibu
1997-2001 Oldsmobile Cutlass
1999-2001 Oldsmobile Alero
1999-2001 Pontiac Grand Am

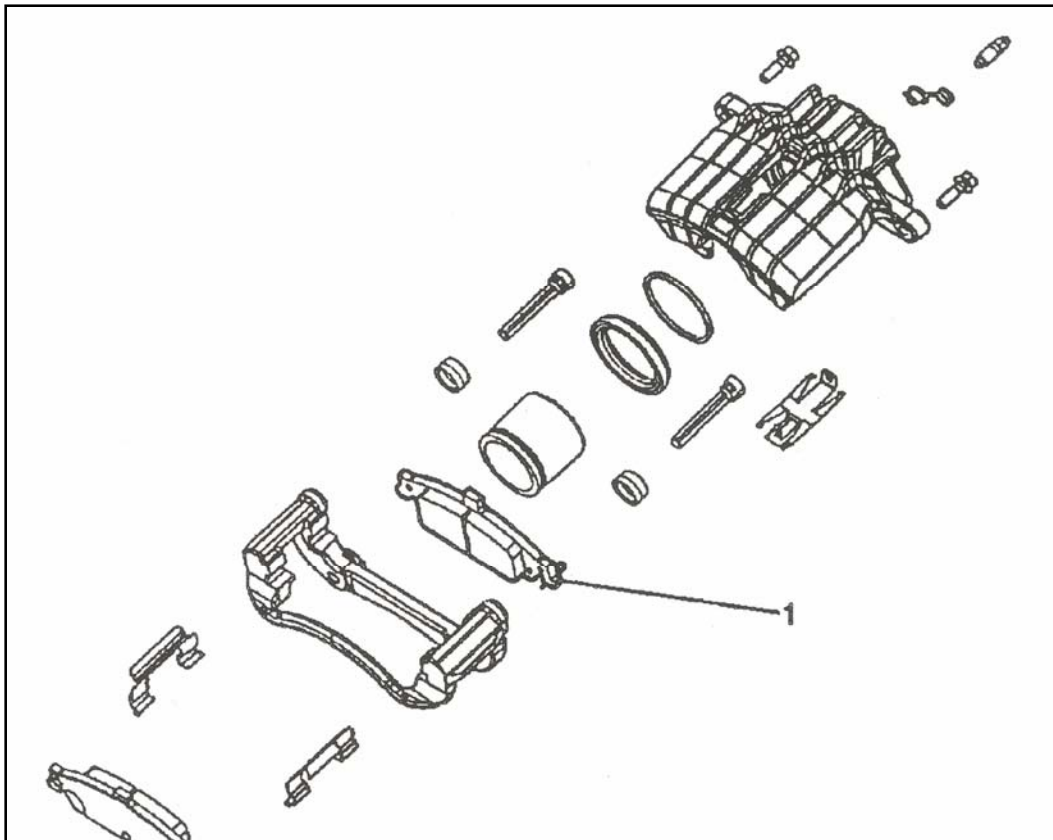
Condition: It may be possible to interchange the outboard and inboard brake pads on the above listed vehicles. If the use of a compact spare tire occurs soon after brake service, interference between the compact spare tire and the caliper may occur. Reduced brake pad service life may also result. Close inspection of the brake pads reveal differences in puck and backing plate dimensions.

Repair Procedure: New front brake pads come with left hand and right hand inner brake pads. When installing the front brake pads, the pads with the **wear indicator** must be installed in the inboard position as illustrated below (1). When the caliper is secured to the car, the wear indicator will be located at the top, just like the bleeder screw.
