**Bulletin BES 13-08**

**Subject:** ABS and Stability control light illuminated

**Vehicles Involved:** 2008-12 Chevy Express/GMC Savana

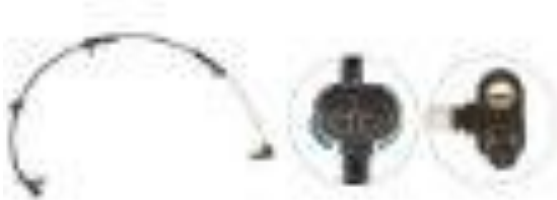
**Condition:** DTC C0045 and/or C0050 stored in EBCM

**Repair Procedure:** The most likely cause for this condition is the front wheel speed sensor harness being misrouted around the front brake hose. This issue may cause the harness to become too taut as it is routed through the suspension. As a result of this condition the wiring at the wheel speed sensor harness may pull out from the connector as the suspension moves up and down. The wheel speed sensor may require replacement. Be sure to route the harness parallel to the brake hose.
