Bulletin BES 02-03

Subject: Diagnosing a sinking brake pedal on Teves 20 Anti Lock Brake System (ABS) Equipped, Import and Domestic Vehicles

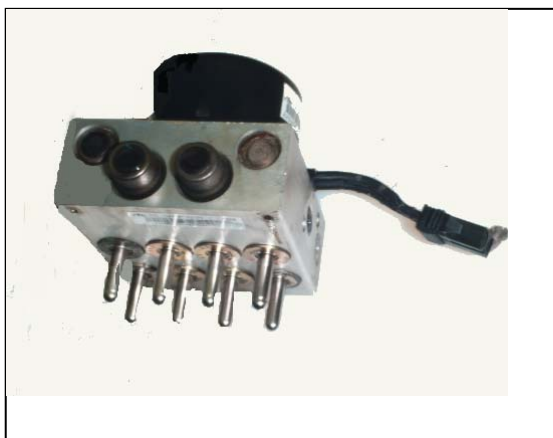
Condition: The Teves 20 anti lock braking system incorporates accumulator test ports. Two black plugs seal the accumulator chambers, permitting easy test access.

Repair Procedure: Technicians should confirm that the base brake system has no leaks or air in the system. Review bulletin **BES 00-06** for low brake pedal isolation procedures. Technicians may then test the ABS hydraulic modulator accumulator function. Locate the two black accumulator plugs. See Fig. 1 below. Remove the small rubber plugs, (approximately ½ inch in diameter). Insert a paper clip into the access hole. Have an assistant start the engine and then apply the brake pedal. If the paper clip moves, the dump valve is stuck open allowing brake fluid to bypass into the spring-loaded accumulator(s). See Fig. 2 below. Test both accumulator pistons for movement. If either accumulator piston moves or leaks fluid out, the hydraulic modulator is defective.
