BRAKE HOSES & CABLES

TECHNICAL BULLETINS

Bulletin BES 17-09

PREMATURE BRAKE WEAR, DRAGGING BRAKES, OVERHEATING BRAKES, NOISE

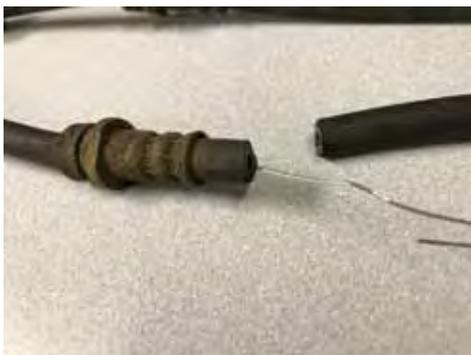
Figure 1

The brake hose may be internally collapsed allowing high-pressure fluid from the master cylinder to apply the brakes but not allow the square cut seal in the caliper to flex back and return piston.

Figures 1 & 2 show the hose cut in half and a paper clip attempting to be pushed thru.

The paper clip could not be pushed all the way in. In this case the metal crimp may have rusted and actually choked the rubber hose. This hose came off a Ford Escape that had new calipers installed for a brake overheating complaint. Needless to say, the vehicle returned in a day or two with the same problem.

To sum it up, don't guess or go with the most popular repair. A thorough inspection that included having an assistant apply the brakes while you watch for proper caliper operation could have prevented this "come back".
