Bulletin BES 04-15

Subject: Accelerated pad wear, brake induced pull, brake pulsation.

Vehicle Involved: 1997-2002 Ford Expedition
1999-2002 Ford F150
1997-1999 Ford F200/250
1998-2002 Lincoln Navigator

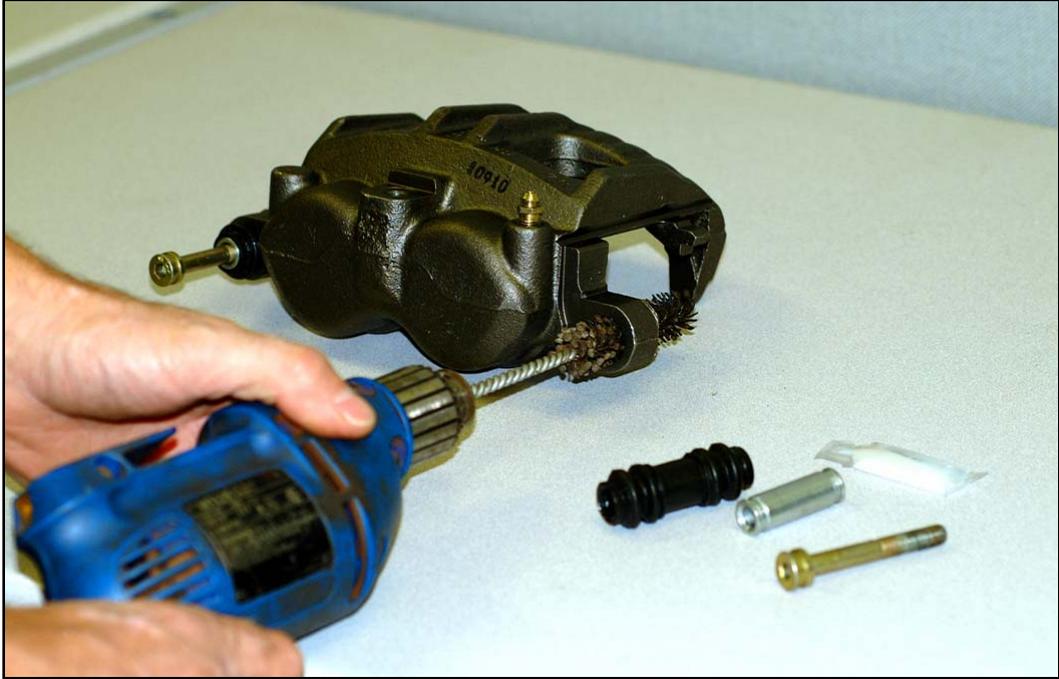
Condition: Build-up of rust and debris underneath caliper mounting pin bushings.

Repair Procedure: The accumulation of rust build-up within the caliper mounting pin bushings reduces the diameter of the caliper-bushing bore. The build-up of rust and debris “squeezes” the rubber bushing around the caliper slide bushing. The floating caliper becomes fixed or very resistant to movement. Accelerated outer pad wear is usually evident. Similar conditions may also result from the use of petroleum-based lubrication applied to the bushings during brake service. Petroleum lubricants eventually swell the rubber bushings, restricting the caliper movement.

While performing disc brake service, begin by removing the caliper pins, steel bushings, and rubber bushings. Hone, sand or wire brush any rust and debris out of the caliper bushing bores. See illustration. Replace the bushings and hardware with NAPA part number 83188. Use NAPA Sil-Glide Brake Lubricant part number 751-1351. Lightly coat the caliper-bushing bore, and apply a light coat of silicone to the rubber bushings. When necessary replace the caliper pin and steel bushings with NAPA part number 83187. Lubricate the steel bushing as well, and reassemble. Please refer to bulletin 03-08 for additional brake service lubrication points.
