Subject: Defective Master Cylinder Reservoir Cap

Vehicle Involved: 2001 Toyota Highlander

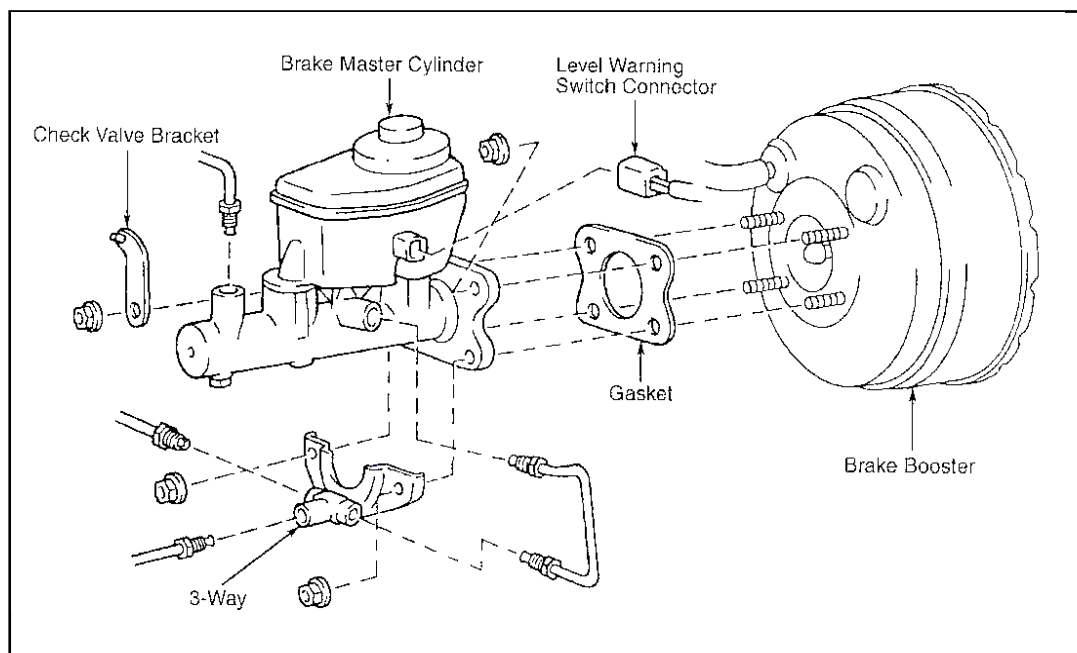
Condition: Abnormal brake noise and increased pedal stroke when the brakes are applied

Repair Procedure: On certain 2001 Model Year Toyota Highlander vehicles, the reservoir filler cap of the brake master cylinder may induce a vacuum, introducing some air into the brake master cylinder reservoir. This may cause abnormal brake noise and increased pedal stroke when the brakes are applied. In the worst case, the increased pedal stroke will lengthen the stopping distance of the vehicle, raising the risk of an accident.

Remove the cap and apply the brake pedal numerous times. If the noise goes away and the pedal stroke has decreased, contact Toyota dealer for a warranty repair and part replacement.

Toyota will replace the brake master reservoir cap with a revised component at no cost. In addition they will bleed the brake hydraulic system and test drive to verify the repair.
