Bulletin BES 01-18

Subject: Re-use of O.E. shims on FWD Continentals, Taurus, and Sable.

Vehicles Involved: 1998 Front wheel drive, Ford, Lincoln, and similar vehicles originally equipped with integrally molded brake pads.

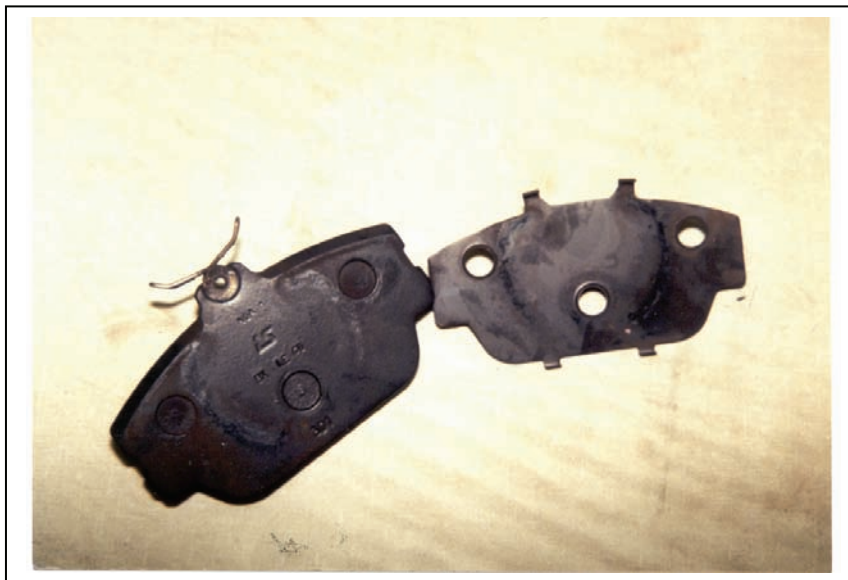
Repair Procedure: The O.E. shims used on these vehicles interlock into the steel plate of the brake pad. The shim is manufactured with a raised dimple that indexes to the original equipment pad. If the O.E. shims are used on certain aftermarket pads, the shim will sit high on the pad. This may create installation problems and allow the shim to slide or move on the metal backing of the pad when the brakes are applied. Do not reuse these O.E. shims. The 1998 vehicles listed above were originally equipped with non-ferrous ceramic brake pads.
